FABRICATION OF TITANIUM THERMAL PROTECTION SYSTEM PANELS BY THE NOR-Ti-BOND PROCESS

NOR 71-202

FINAL REPORT ON CONTRACT NO. NAS8-26810

October 1971

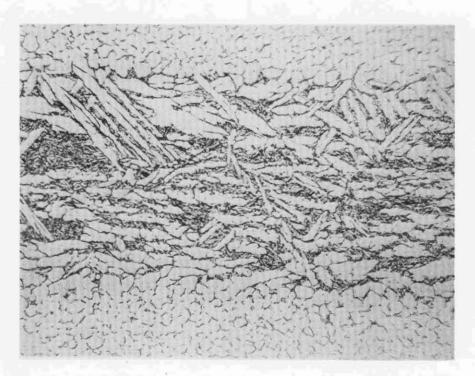
FIGURE 3 JOINT MICROSTRUCTURE FROM NASA TPS PANELS NO. 1. MAXIMUM COPPER CONTENT 6.4%

A typical microstructure of a NOR-Ti-BOND joint is shown in Figure 3. The original liquid region represents about 1/4 of the apparent joint. The remainder of the Widmanstatten and other structures are the result of solid-state diffusion of copper into the titanium. This diffusion transformed the areas to beta titanium. The large, light-gray needles are alpha-titanium; the darker regions within the joint are a mixture of alpha-titanium and Ti₂Cu compound in a platelet structure similar to that of pearlite in steel.

For the subsize panel brazement, a diffusion treatment of 2-1/2 hours at 925C (1700F) was used. An electron microprobe analysis determined that the maximum copper concentration at the joint center was 7.1 percent. Therefore, we adjusted the diffusion treating cycle to three hours at 925C (1700F). This resulted in a microstructure with a coarse basket-weave of alpha needles and dispersed grains of alpha plus Ti₂Cu compound in a perlitic form (Figure 3). After this treatment, the microprobe analysis indicated a maximum copper concentration of 6.4 percent.

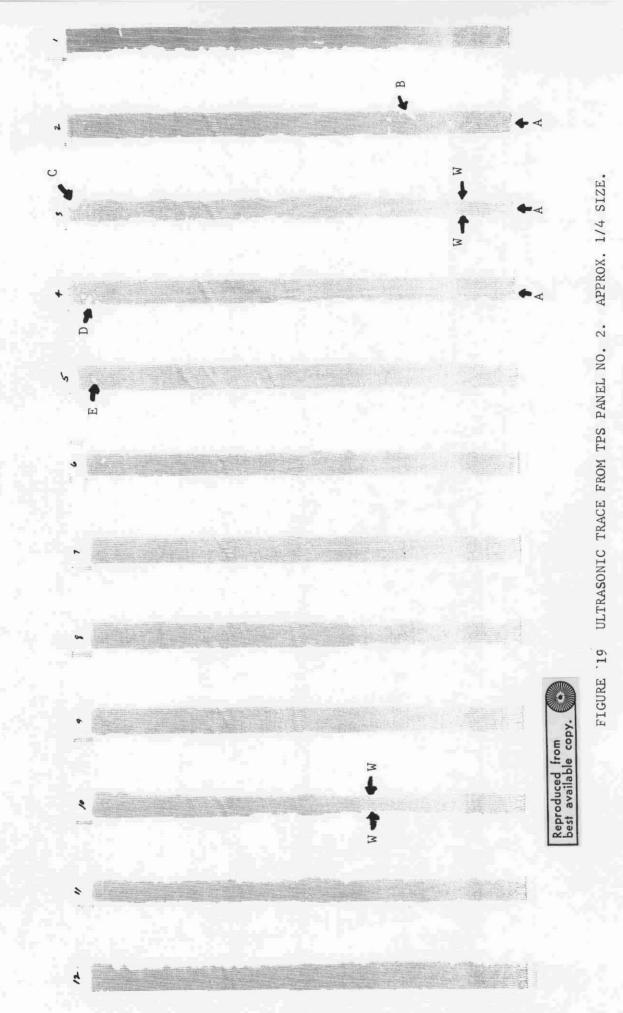
For purposes of this detailed discussion, a reduced-in-size reproduction of the ultrasonic scan and the X-ray films will be used from TPS panel No. 2. The full-size inspection data for each of the five panels is shipped with the panels. An examination of the ultrasonic trace (Figure 19) and of the X-ray prints (Figures 20, 21, and 22) shows that hat-sections No. 2, 5, 7, and 9 are well joined, full width joints. Hat-sections 1, 4, 6, 8, 11, and 12 are well joined but have a somewhat narrower joint width. Hat-sections No. 3 and 10 have narrow joint widths (W-W) occuring along their length. In almost all cases, it would appear that no significant voids occur throughout the center portion of the joints. Small disbonds are noted on the ultrasonic traces at the ends of hat-sections 2, 3, and 4(A). However, the X-ray only shows a small void at the end of section 3. Various reasons can be given for these defects. The slight end defect on hat-section No. 3 probably occurred due to a slip of the shimming stock used to support the end during joining.

The joint width problems are a little more difficult to pin down. They can be caused by slight crowning during the forming operation of the flat of the facesheet or of the flat of the hat-section, or by the tendency for the Zircar to powder around the edges, or by unevenness of the flame sprayed-pressure bar, or by the tooling height which supports the clamshells on the wave portion of the facesheet. If this height were incorrect, it would tend to lift the sheet, causing a larger gap between the sheet and the hat-section.

A few of the areas which show up on the ultrasonic trace and which show very dimly on the X-rays can be pointed out on the side of hat-section 2(B), at the top side of hat-section 3(C), and along the side near the top of section 4(D), and near the center top of section 5(E). Each of these indicate that something has occurred in this region. The exact

interpretation of these spots is uncertain as panels could not be sectioned. It is possible, but somewhat doubtful, that these are voids. More likely, they are partially joined regions, that is, a mixture of void and joint, or even an area in which the composition of the joint varies from that of the surrounding area. The X-rays indicate that these areas are slightly less dense than the surrounding area. These slightly less dense indications could be that of a void or it could also be areas in which the copper-containing liquid has been squeezed out, thus minimizing the quantity of copper in that region. Or it could be that a wrinkled copper foil was used, which entrapped argon gas, causing a small gas pocket to be formed. Insufficient standards are available at this time for confirming what these indications really mean.

The corrections for these problems would be to modify the tooling as follows: carefully check the thickness and position of the end shim to eliminate the end gaps. This condition is aggravated by slight changes in the thickness of the hat-sections such that consistent errors will not occur in this region. The joint width problems can be corrected by better forming of the parts, by widening the bars and the compression pad to a greater width such that edge effects will not show up in joint quality, by improving the flame-sprayed bar, and, finally, by carefully matching the clamshell support tooling to the height of the waves in the facesheet. Part of this problem can be related to inconsistencies in hand forming of the wave-shaped facesheet and part of the correction would be to fabricate more consistent facesheets.

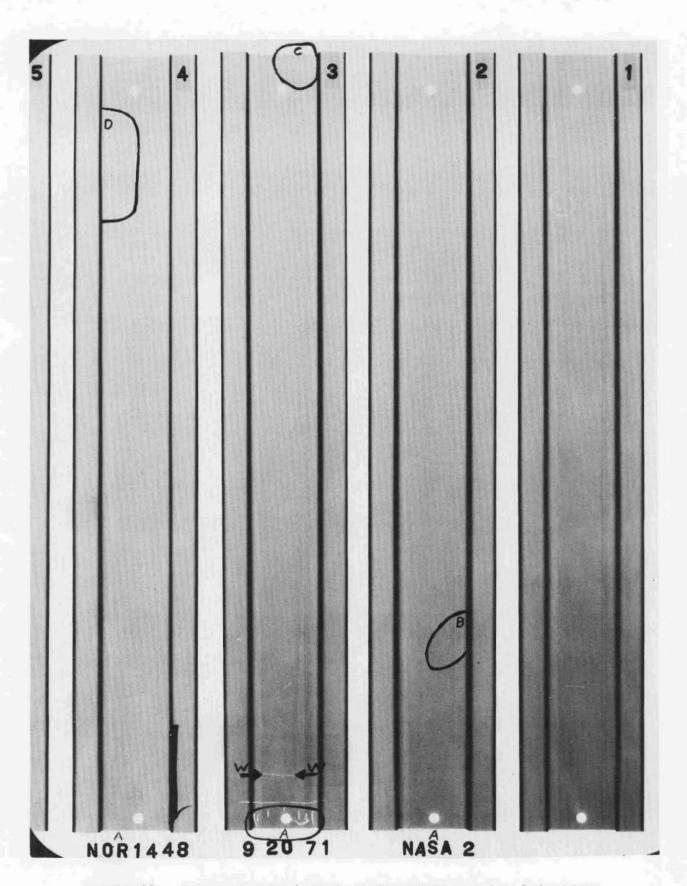
FIGURE 20 X-RAY OF HATS 1 TO 4 OF TPS PANEL NO. 2. 0.6 SIZE

TPS Panel No. 2 - This panel shows visual improvement over No. 1 in that fewer ripples occurred in the wave-shaped facesheet. However, several creases occurred across the flats at the end of the hat-section to facesheet joint. These creases occurred on hat-sections No. 3, 5, 9, 10, 11, and 12. Their cause was traced to a shifting of the spacer pieces used to compensate for the thickness of the hat-section.

The curvature of the wave appeared satisfactory, and the general configuration of the hat-sections is satisfactory. Some opening of the hat-section channels occurred. This led to a change in tooling for supporting the hat-section bends of the next panel. Two NDT inspections were conducted using through transmission ultrasonics and X-ray. The results of these two tests collaborate that hat-section No. 1 has some disbond on the one side of the faying surface. No. 2 seems to be quite good with a couple of small indications occurring which, at this time, cannot be adequately verified or identified. Hat-section No. 3 has a somewhat narrow joint with some disbond along either side of the hat-section. Nos. 4, 5, 6, 7, 8, and 9 are good joints. No. 10 is the narrowest joint on the panel. In one section of No. 9, the faying surface is only 1.5 cm (0.59-inch) in width. Hat-section Nos. 11 and 12 had some disbond along one side, but are reasonably good.
